8 Paving Troubleshooting

Long-term pavement performance is the result of the smoothness and mat quality of the HMA mixture. Smoothness affects the transportation costs of the road user to include vehicle maintenance costs, fuel consumption, speed, passenger comfort, safety, and vehicle noise. Poor mat quality also affects the pavement performance and may be caused by cracks, segregation, poor joints, and other defects. Furthermore, low density may cause the mix to deform, make the mix more susceptible to moisture, prematurely harden the asphalt, decrease the fatigue resistance, or reduce the structural strength of the pavement.

This chapter will discuss the problems that affect the smoothness and quality of the pavement mat and the possible solutions for correcting these deficiencies. Problems may be detected by observing the mixture in the truck or Material Transfer Vehicle (MTV) during the transfer of the mixture to the paver, by observing the mixture after the paving operations, and by observing the mixture during the compaction process.

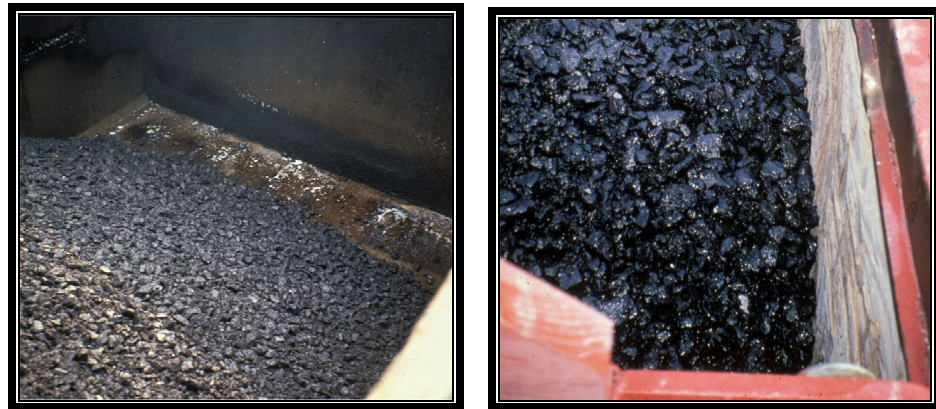
Figure 8-1. End of Truck Segregation

MIXTURE NOT UNIFORM (FIGURE 8-1)

1. Leaky Bins
2. Segregation of aggregates in bins
3. Carryover in bins due to overloading screens
4. Insufficient aggregates in hot bins
5. Faulty distribution of asphalt to aggregates
6. Irregular plant operation

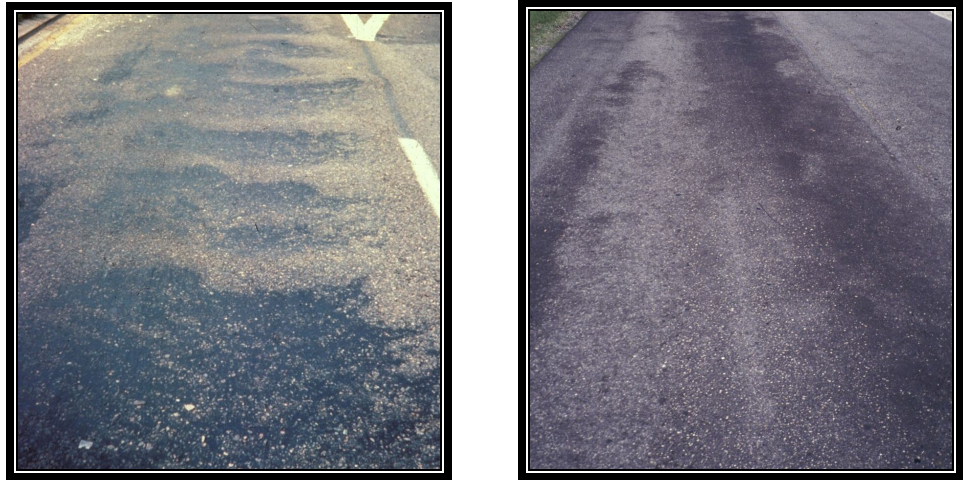
Figure 8-2. Bleeding

BLEEDING (FIGURE 8-2)

1. Prime or tack coat too heavy (Figure 8-3)
 - a. Use correct prime or tack coat application rates

2. Poor prime penetration
 - a. If granular base is too moist, allow drying period or re-work base material
3. Segregation of HMA
 - a. Can be due to many factors including materials handling, mix gradation, operation and condition of storage bins, paver operations, etc.
4. Moisture

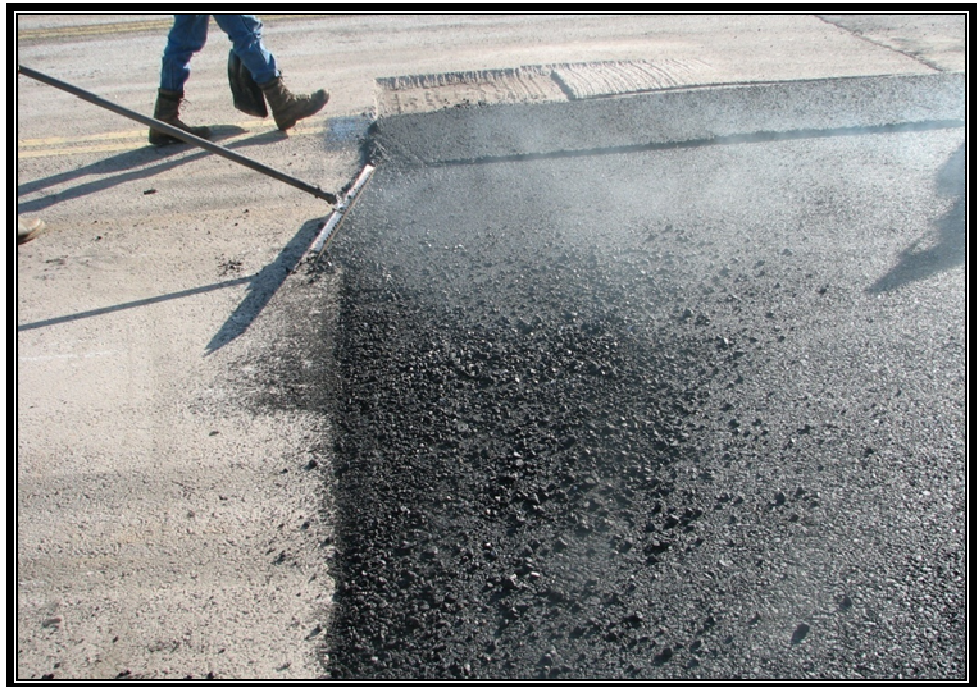
Figure 8-4. Poor Raking at Joint

1. Poor compaction technique
 - a. Roll joint transversely
 - b. Use correct compaction technique
2. Poor raking technique or excessive raking (Figure 8-4)
 - a. Minimize raking
 - b. Trim and remove any excess from cold side of joint

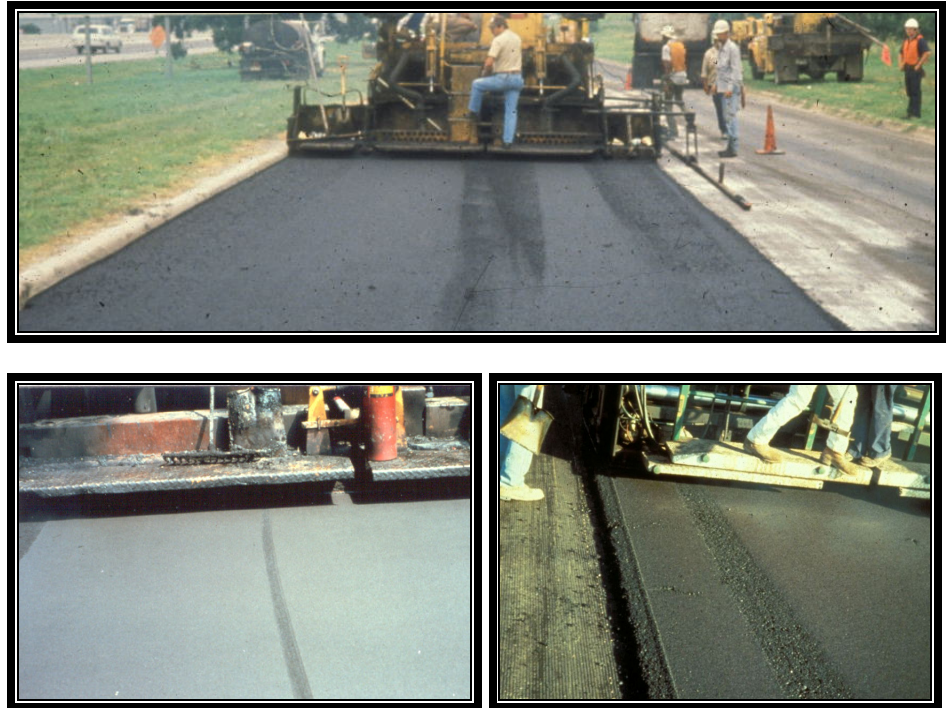
Figure 8-5. Screed Marks

SCREED MARKS (FIGURE 8-5)

1. Thickness control screws in poor mechanical condition
 - a. Replace control screws
2. Variable material level in front of screed
 - a. Adjust hopper gates and/or feed conveyor/spreading screw speeds
 - b. Adjust depth sensor
3. Improper operation of paver
 - a. Use proper paving procedures
 - b. Release brakes on truck
4. Truck bumps paver or is not square with paver (Figure 8-6)
 - a. Allow paver to approach truck
 - b. Make sure all rear wheels of truck are in contact with roller bar on paver

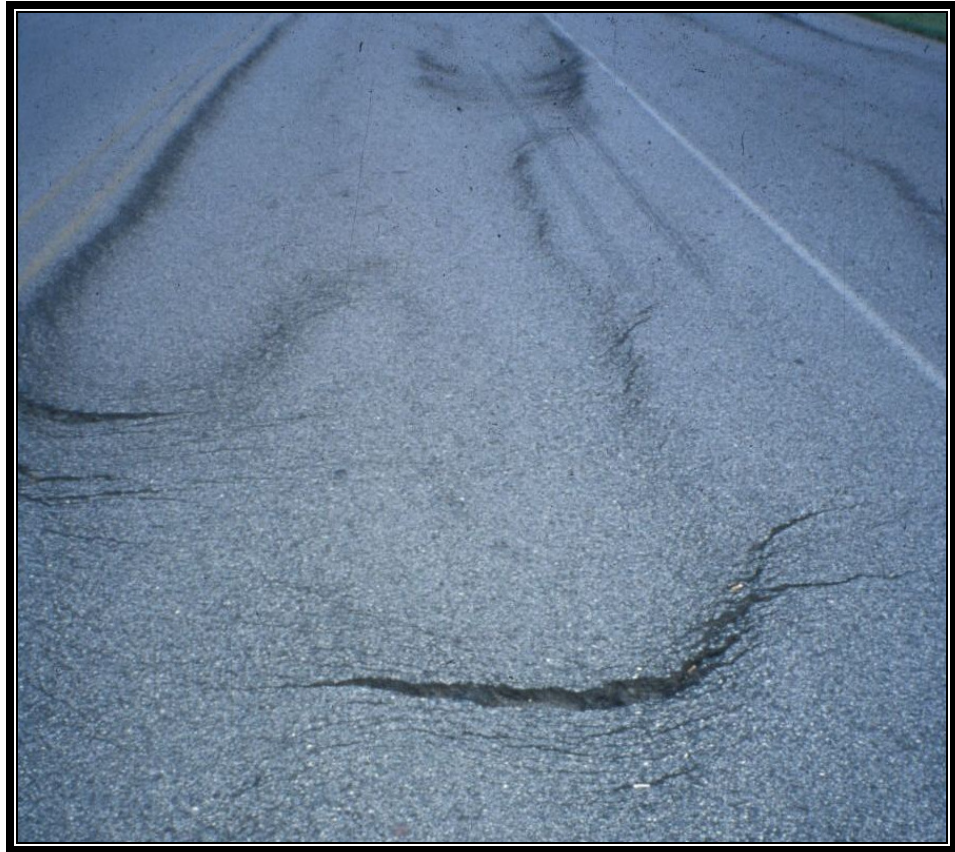
Figure 8-7. Mat Tearing Full Width

TEARING OF MAT – FULL WIDTH (FIGURE 8-7)

1. Stone size too large for layer thickness
 - a. Reduce stone size to a maximum of half of the layer thickness
 - b. Revise mix design
2. Tender Mix
 - a. Check mix proportions
 - b. Revise design if excess sand, low filler content, or high asphalt content
 - c. Check and correct if moisture in mix
 - d. Check asphalt grade and temperature-viscosity characteristics
3. Forward speed of paver too fast
 - a. Reduce paver speed
4. Worn out screed plate
 - a. Replace screed plate
5. Mix too dry or too harsh
 - a. Check if mix may be too coarse or aggregates too dirty
 - b. Increase VMA and asphalt content
 - c. Consider addition of natural sand

6. Mix temperature too low
 - a. Increase mix temperature at plant according to temperature-viscosity characteristics or in accordance with asphalt supplier recommendations
 - b. Cover load during hauling and waiting
7. Rapid cooling of mat surface
 - a. Check air temperature and wind chill effects
 - b. Increase number of rollers
 - c. Reduce forward speed of paver
8. Cold paver speed
 - a. Heat screed

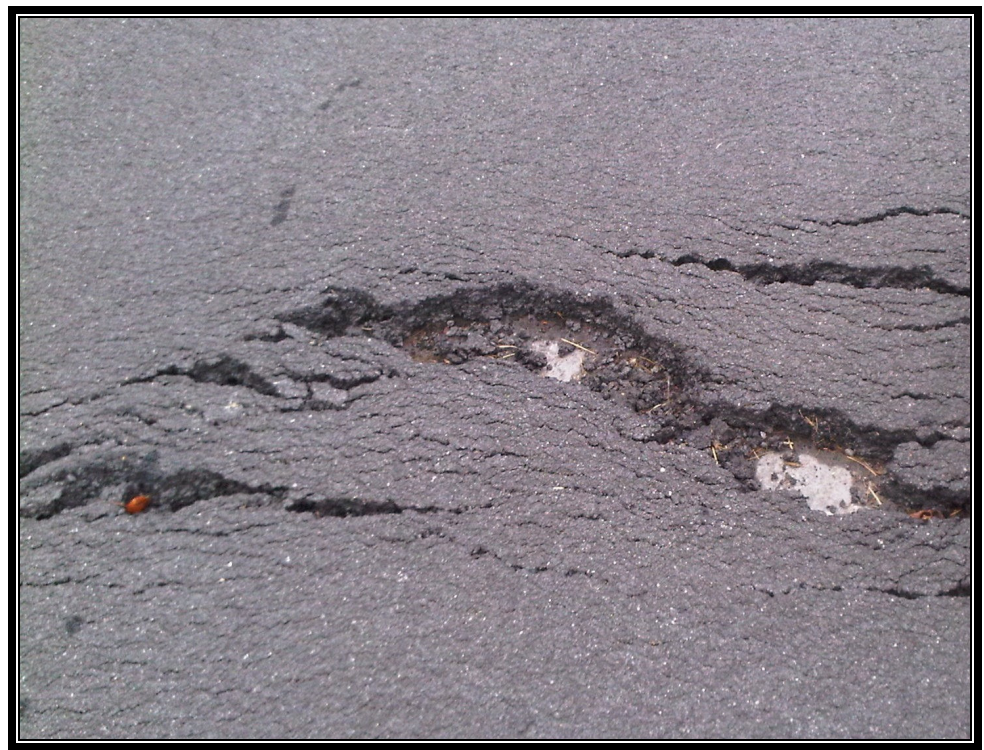
Figure 8-8. Tearing of Mat – Center

TEARING OF MAT – CENTER (FIGURE 8-8)

1. Not enough lead crown
 - a. Increase lead crown
2. Mix temperature too low
 - a. Increase mix temperature at plant according to temperature-viscosity characteristics or in accordance with asphalt supplier recommendations
 - b. Cover load during hauling and waiting
3. Worn screed plate
 - a. Replace screed plate

4. Incorrect feeder gate setting
 - a. Correct feeder gate setting
5. Kicker screws worn out or mounted incorrectly
 - a. Replace or adjust kicker screws
6. Segregation of HMA at centerline (Figure 8-9)
 - a. Could be due to many factors including stockpiling procedures, mix gradation, operation and condition of storage bins, paver operations, etc.

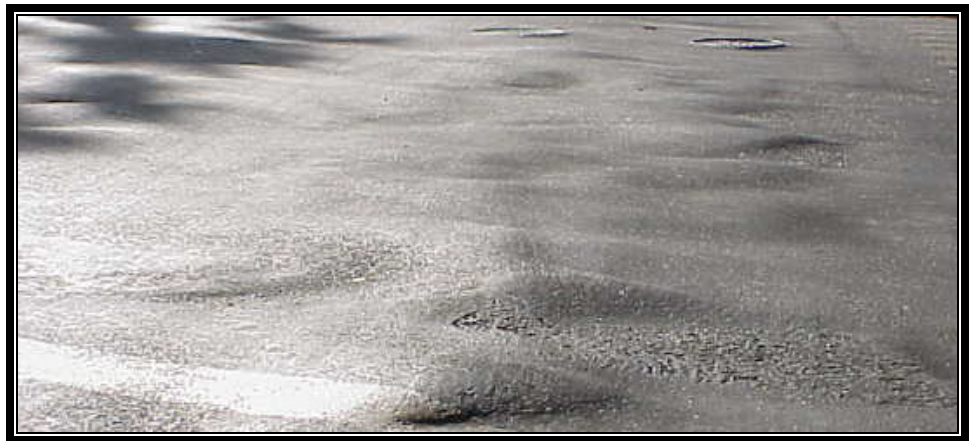
Figure 8-10. Unstable HMA

6. Poor asphalt content control
 - a. Evaluate sampling and testing procedures
 - b. Use Quality Control charts
 - c. Check asphalt meters or weigh buckets
 - d. Check belt scales
7. Over-controlling of screed
 - a. Adjust automatic controls to more closely meet mat thickness
 - b. Make sure automatics are adjusted to correct sensitivity as recommended by manufacturer
 - c. Check for smooth uniform movement of tow point cylinders
8. Unstable or tender HMA (Figure 8-10)
 - a. Check mix proportions and aggregate quality
 - b. Revise design if excess sand, low filler content, or high asphalt content
 - c. Check and correct if moisture in mix
 - d. Check asphalt grade and temperature-viscosity characteristics

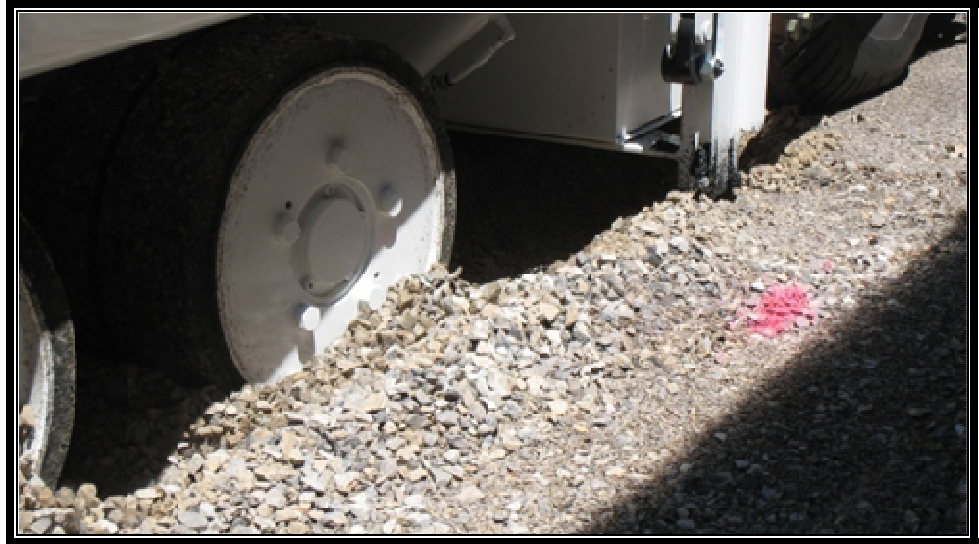
Figure 8-11. Yielding Granular Base

11. Yielding underlayer – granular bases (Figure 8-11)

- a. Improve or modify
- b. Check density
- c. Do not lay HMA over a saturated base
- d. Check drainage

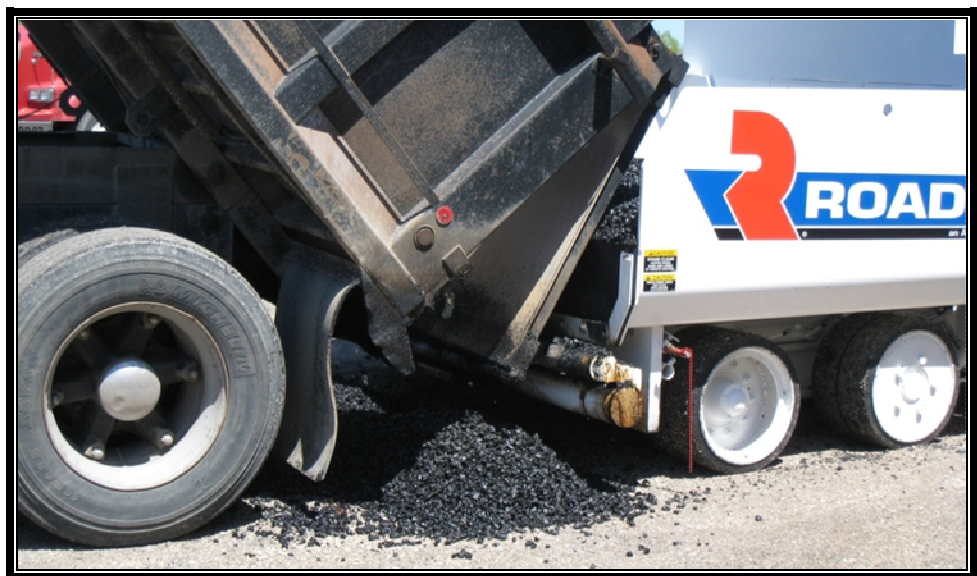
Figure 8-12. Dumped Material on Pavement

13. Material on existing pavement (Figure 8-12)

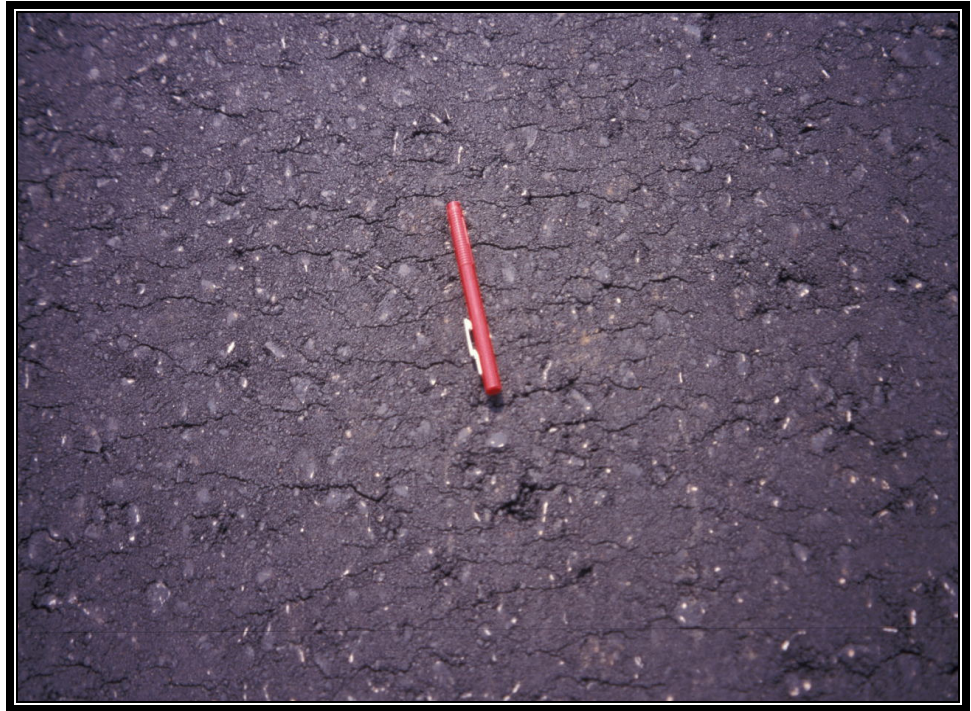
Figure 8-15. Checking Under Roller

CHECKING UNDER ROLLER (FIGURE. 8-15)

1. Yielding underlayer – granular bases
 - a. Check density
 - b. Do not lay HMA over a saturated base
 - c. Check drainage
2. Yielding underlayer – overlays
 - a. Cut out and patch weak areas
3. Tender mix
 - a. Check mix proportions and aggregate quality
 - b. Revise design if excess sand, low filler content, or high asphalt content
 - c. Check and correct if moisture is in mix
 - d. Check asphalt grade and temperature-viscosity characteristics
 - e. Change position of roller in the pattern (vibratory to intermediate, static to breakdown, etc.)
4. Poor asphalt quality
 - a. Check that asphalt has not been overheated or contaminated with harder grade
 - b. Check with supplier
 - c. Test asphalt properties

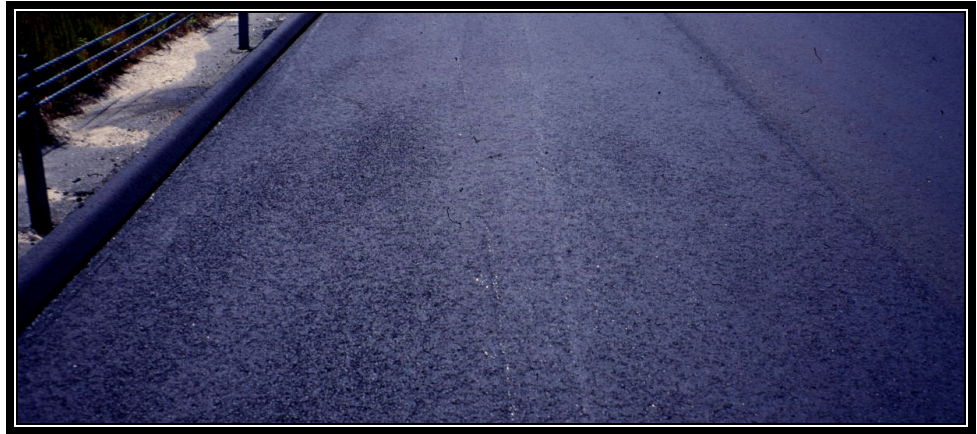
Figure 8-19. End of Truck Segregation

11. Segregation of HMA

- a. Could be due to many factors (Figure 8-19)
